Alabama A&M University

**Masterplan Revitalization Project
Community Meeting
September 18, 2019**

Masterplan Revitalization Project

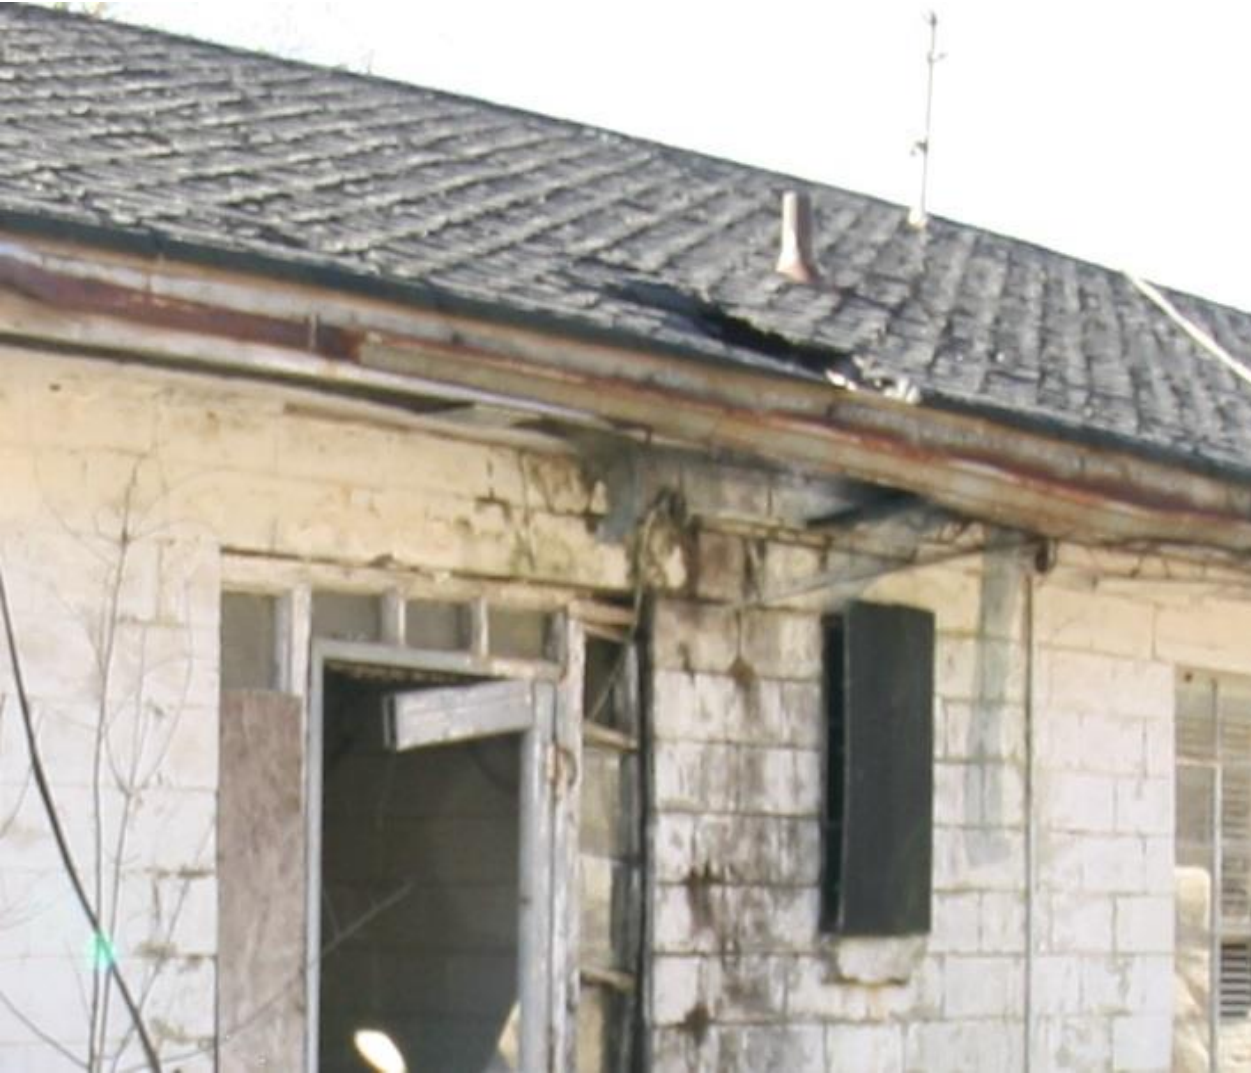
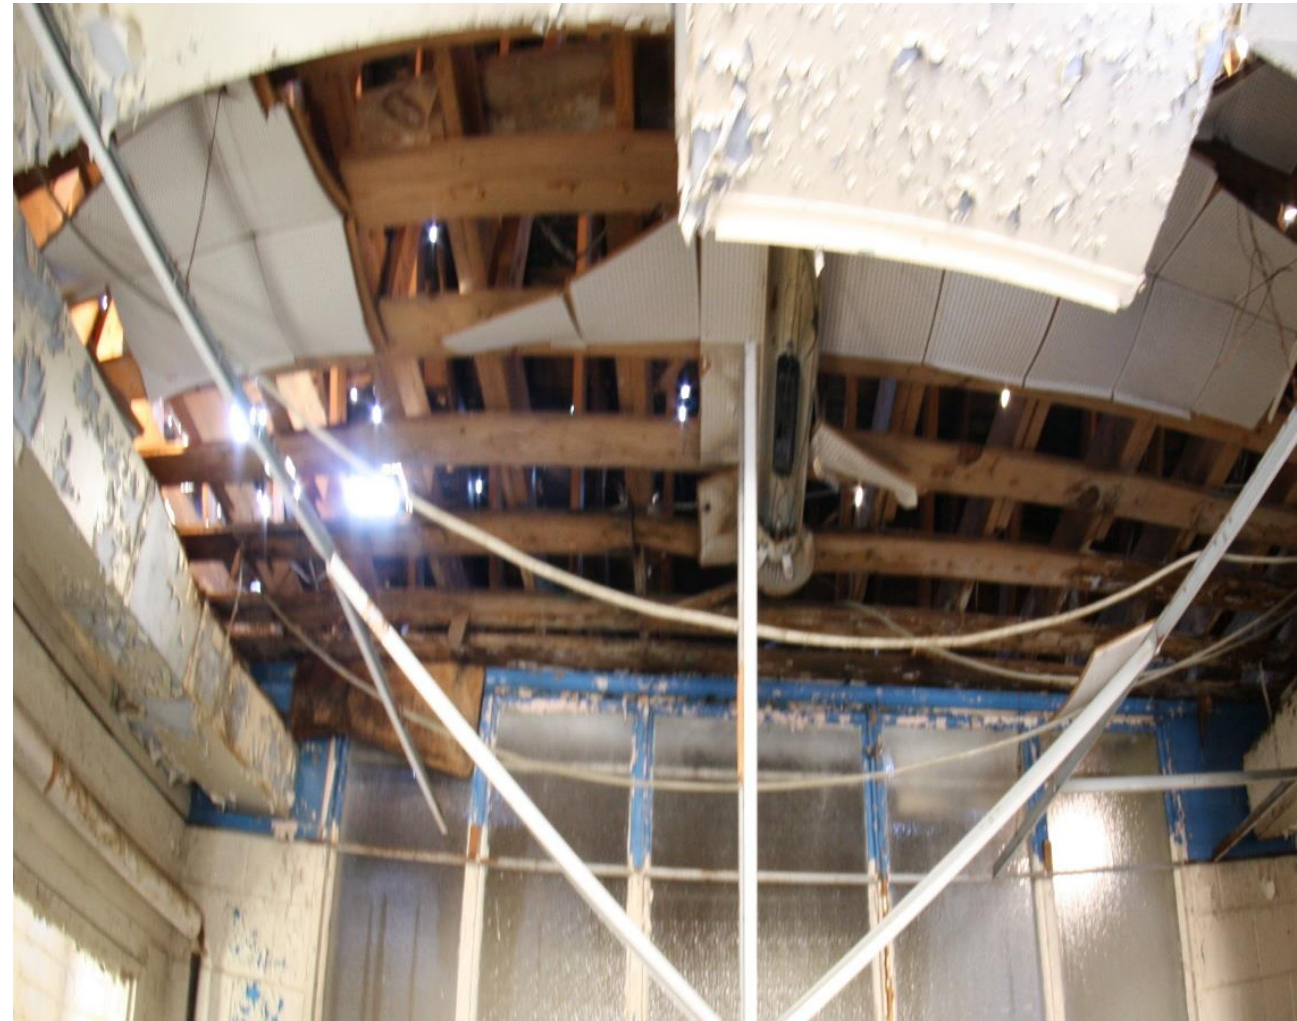
Former Shop Building

The photo on the left shows hole in the roof rotten soffits, doors and windows. The photo on the right shows an interior view of the various holes in the roof structure.

- No service to students or staff
- Renovation cost \$740,000
- ROI is unknown

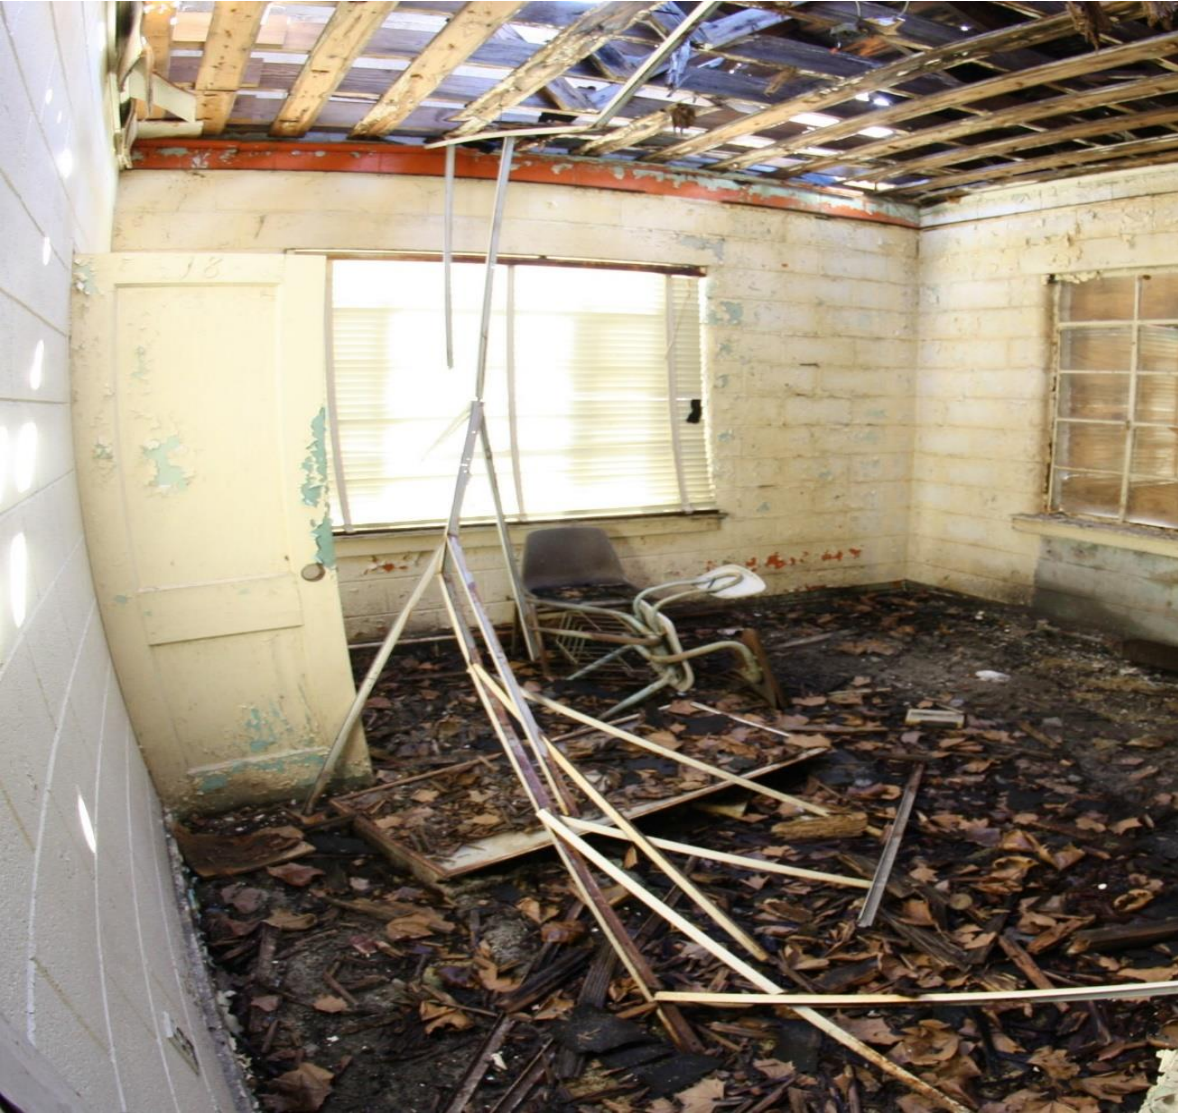
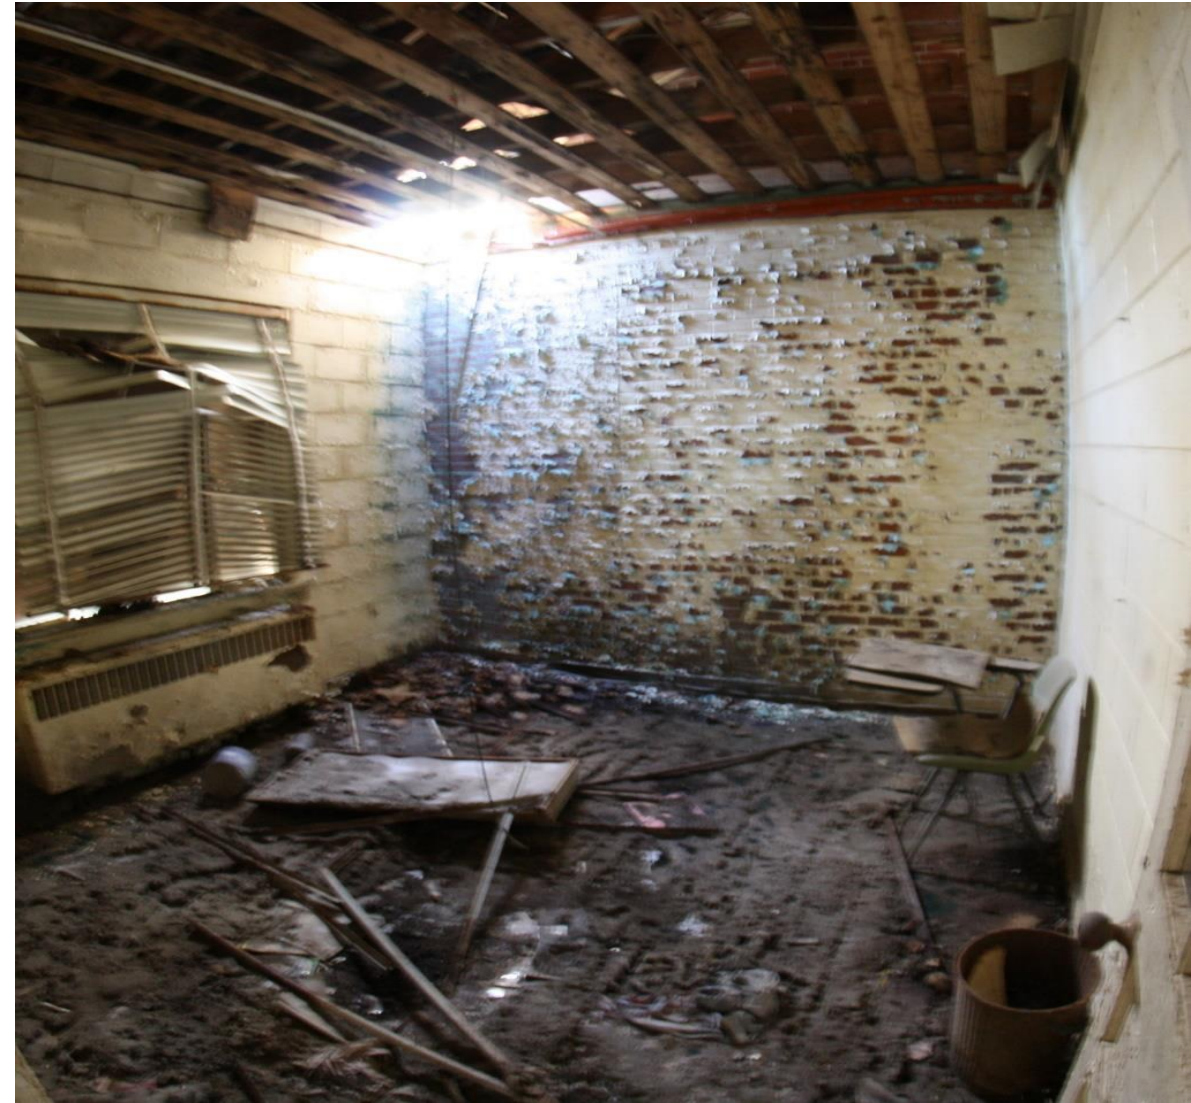
Former Shop Building

The photos below shows the damage to the interior of the building.

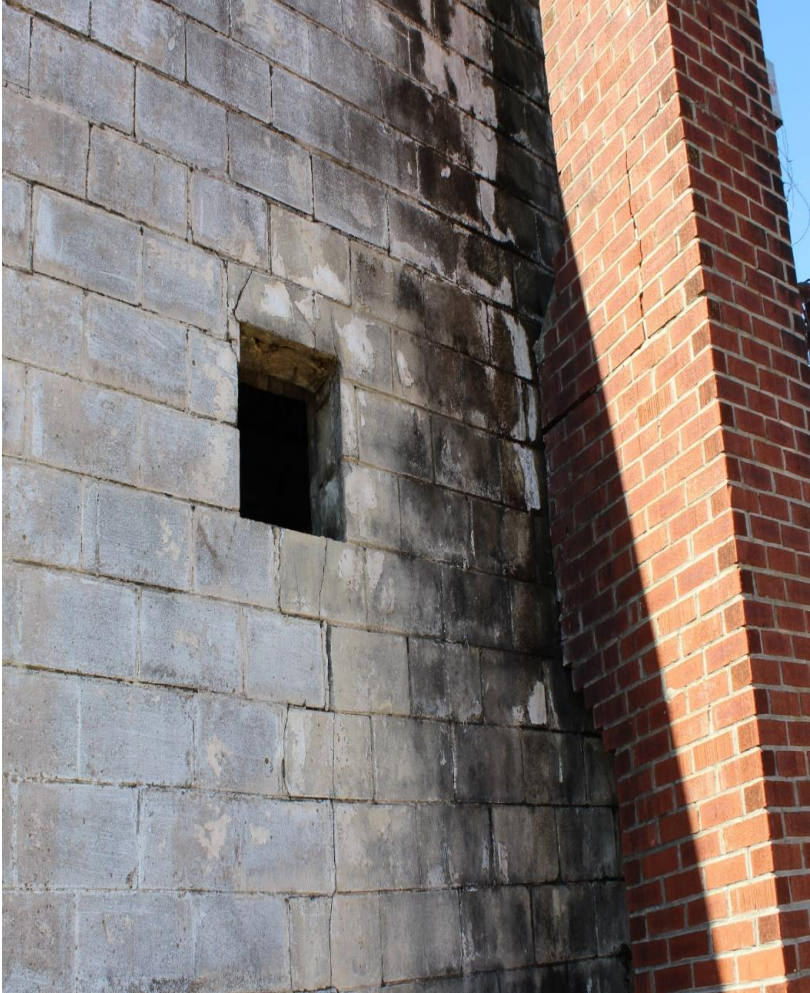
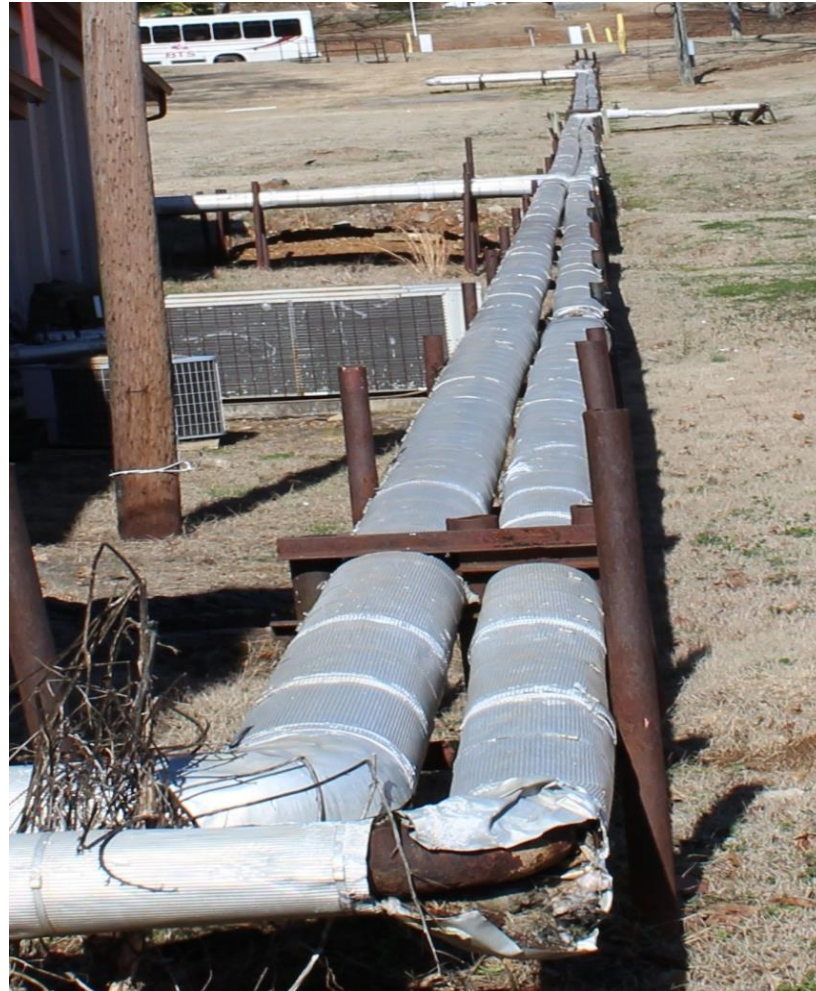
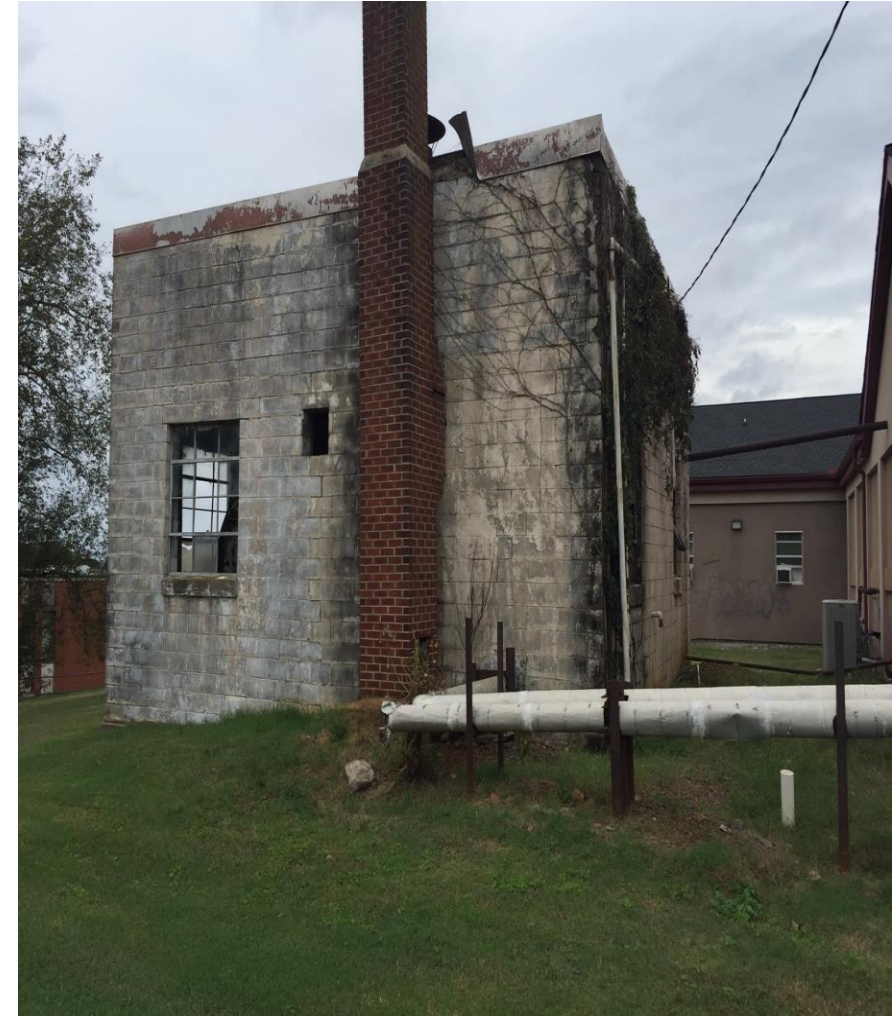
Boiler Room #2

The photo on the left shows structural cracking in the building and the brick smoke stack. The center photo shows the abandoned steam piping that served the buildings such as Grayson Hall and McCalep Hall.

- Current structure has no current appropriate use
- ROI is unknown

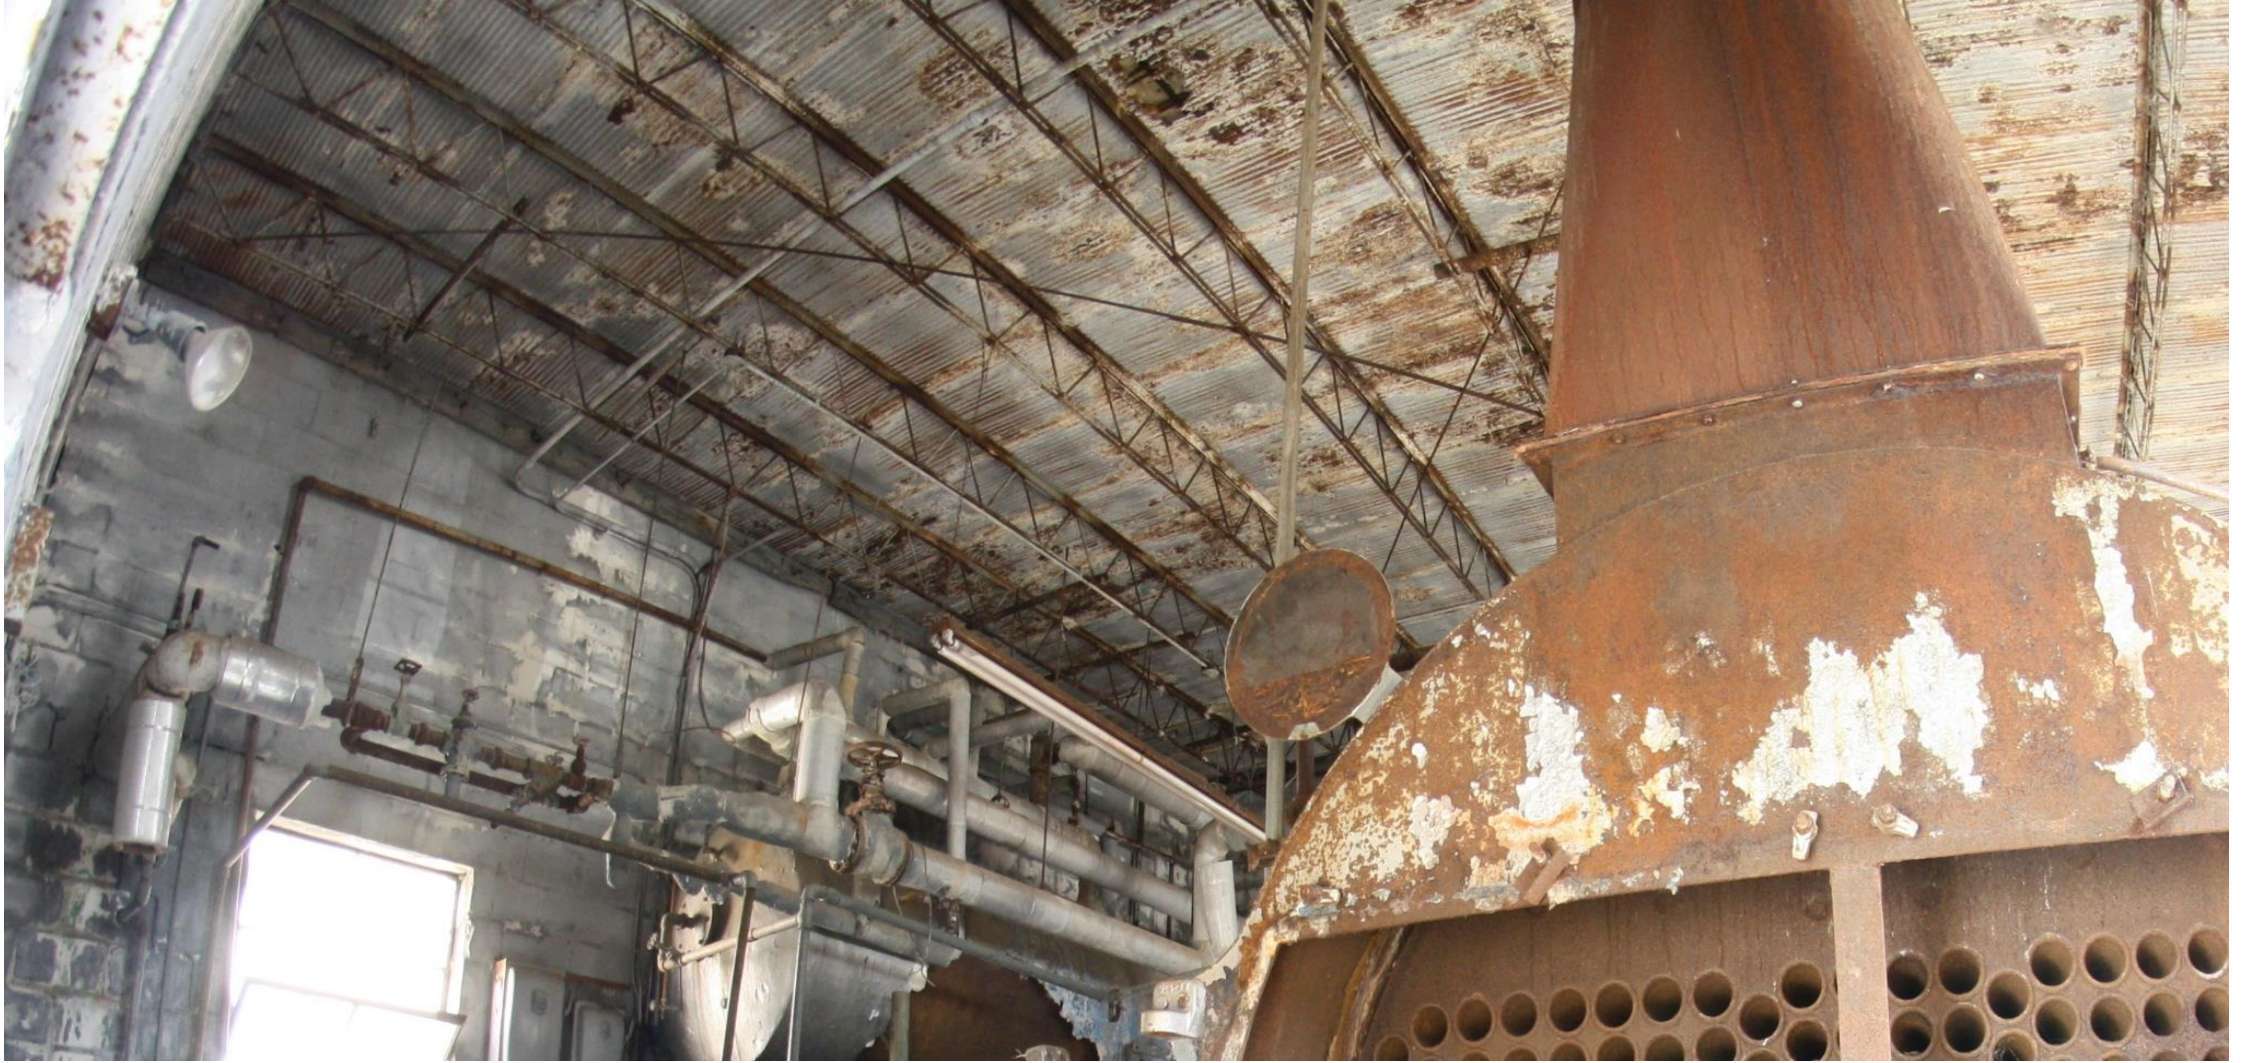
Boiler Room #2

The picture below shows damage to the interior web joist, old boiler, storage tanks and asbestos pipe insulation.

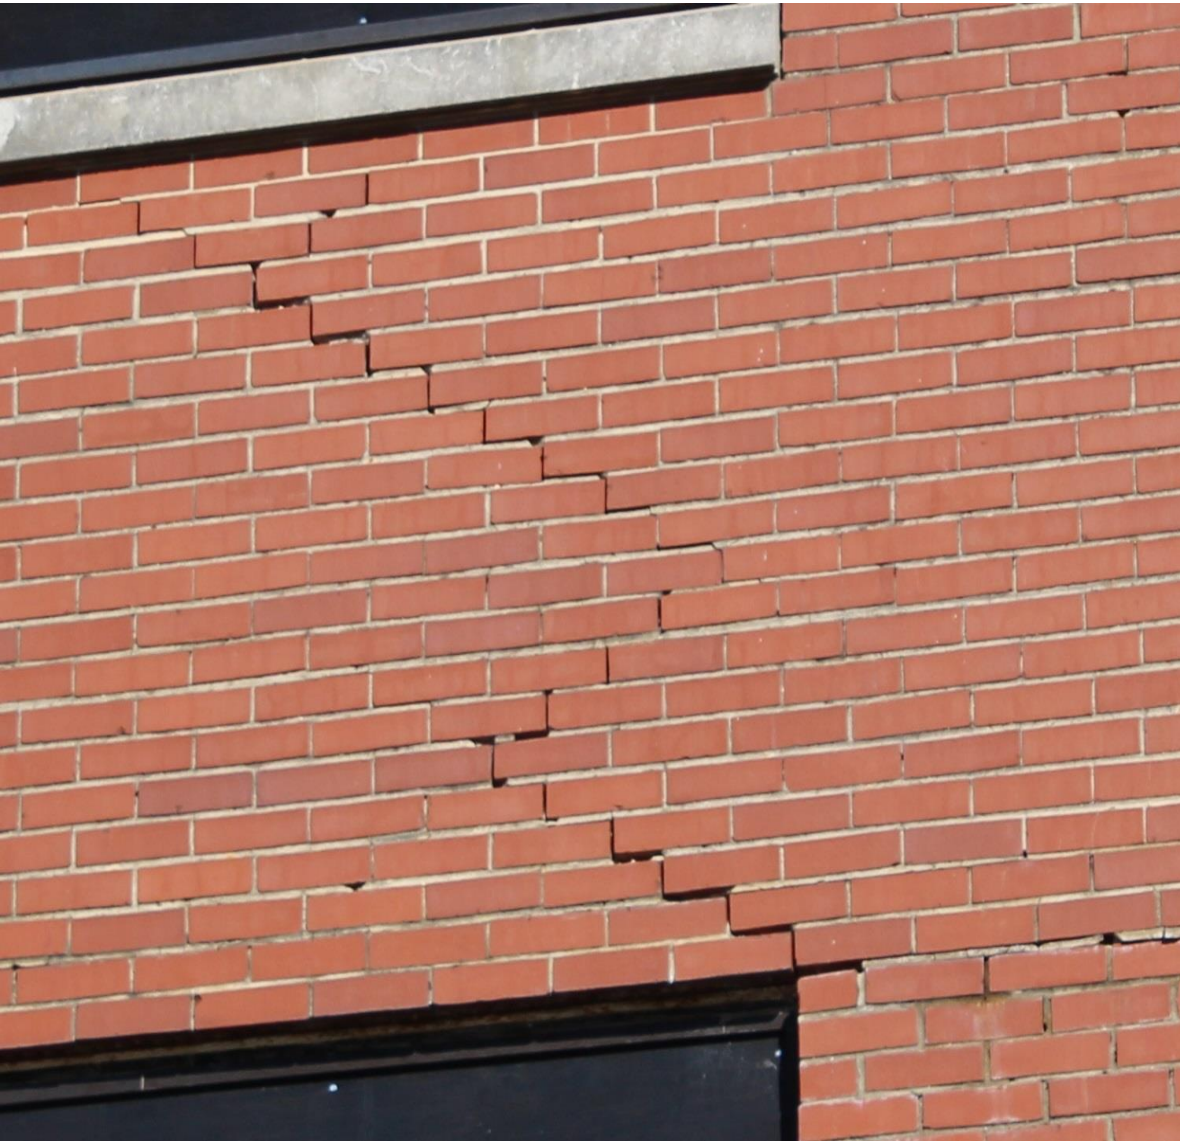
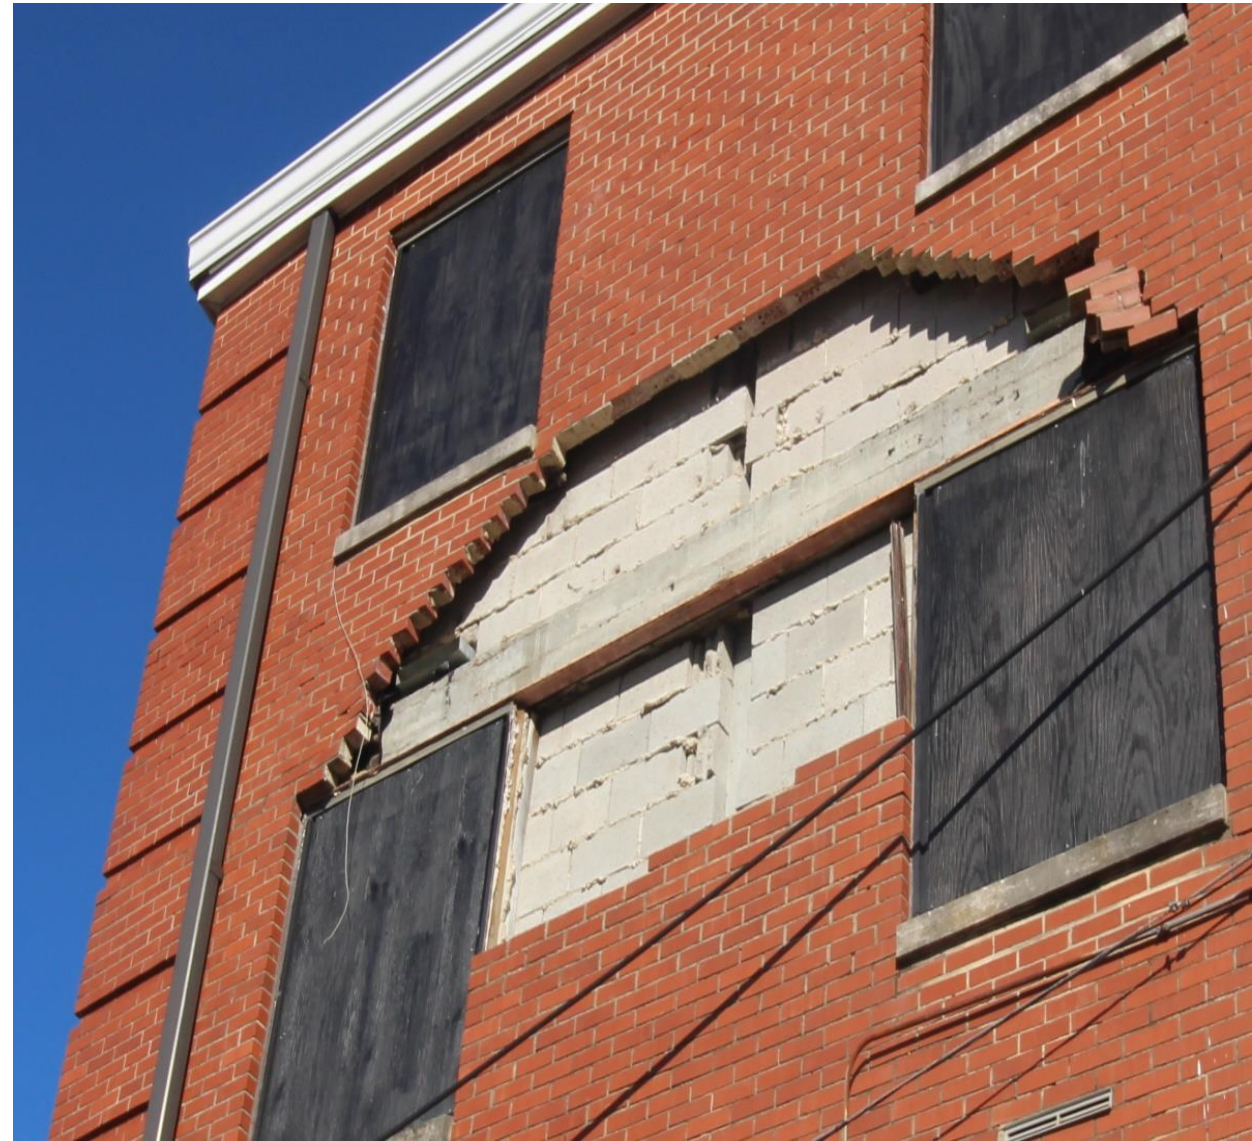
Walker Wood

The photo on the left shows settling cracks in the building that allows moisture between the brick façade and the interior CMU walls. The photo on the right shows a failure of the brick façade due to water infiltration through stress cracks.

- Service 180 students
- Renovation Cost \$7,435,000
- ROI of 16 years (ROI Goal is 6 to 8 years)

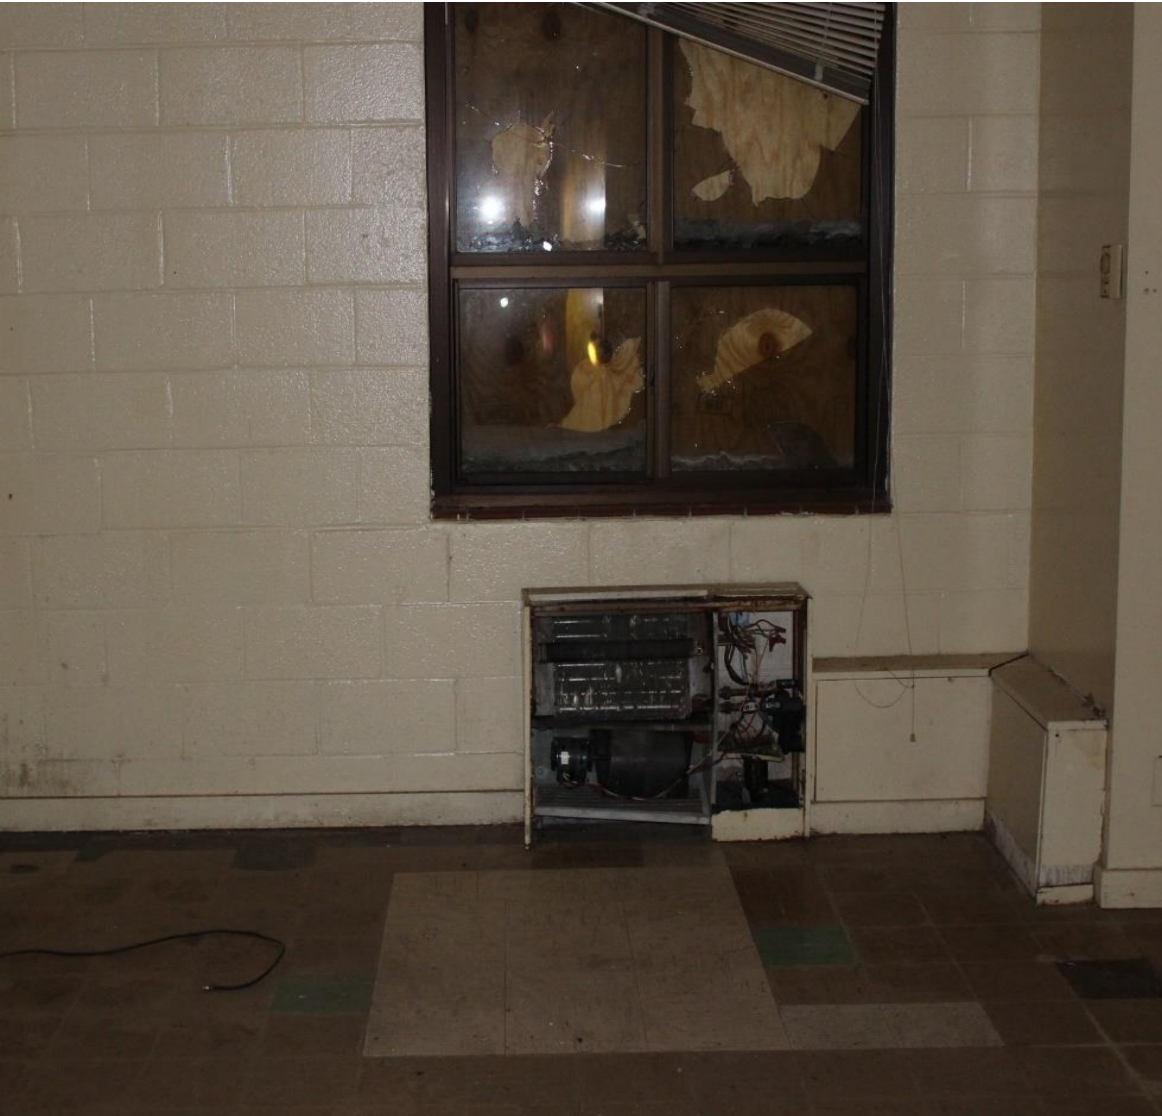
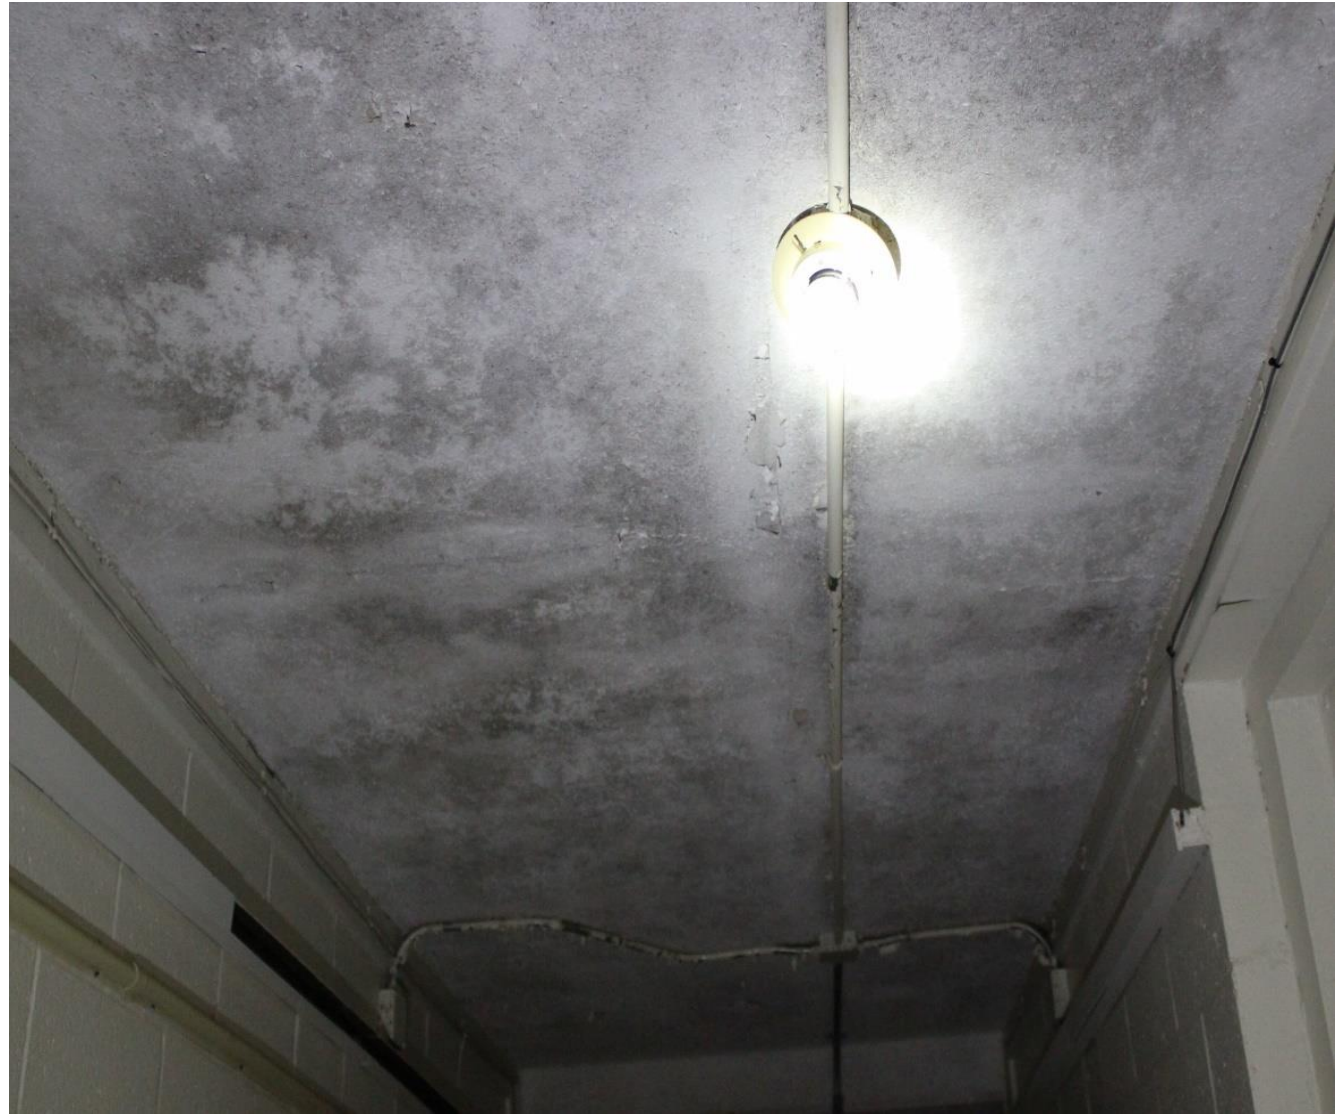
Walker Wood

The photo on the left shows the condition of a typical residence room with asbestos floor tile, broken insulated windows, and non-working HVAC system. The photo on the right shows a typical asbestos ceiling that is saturated with mold.

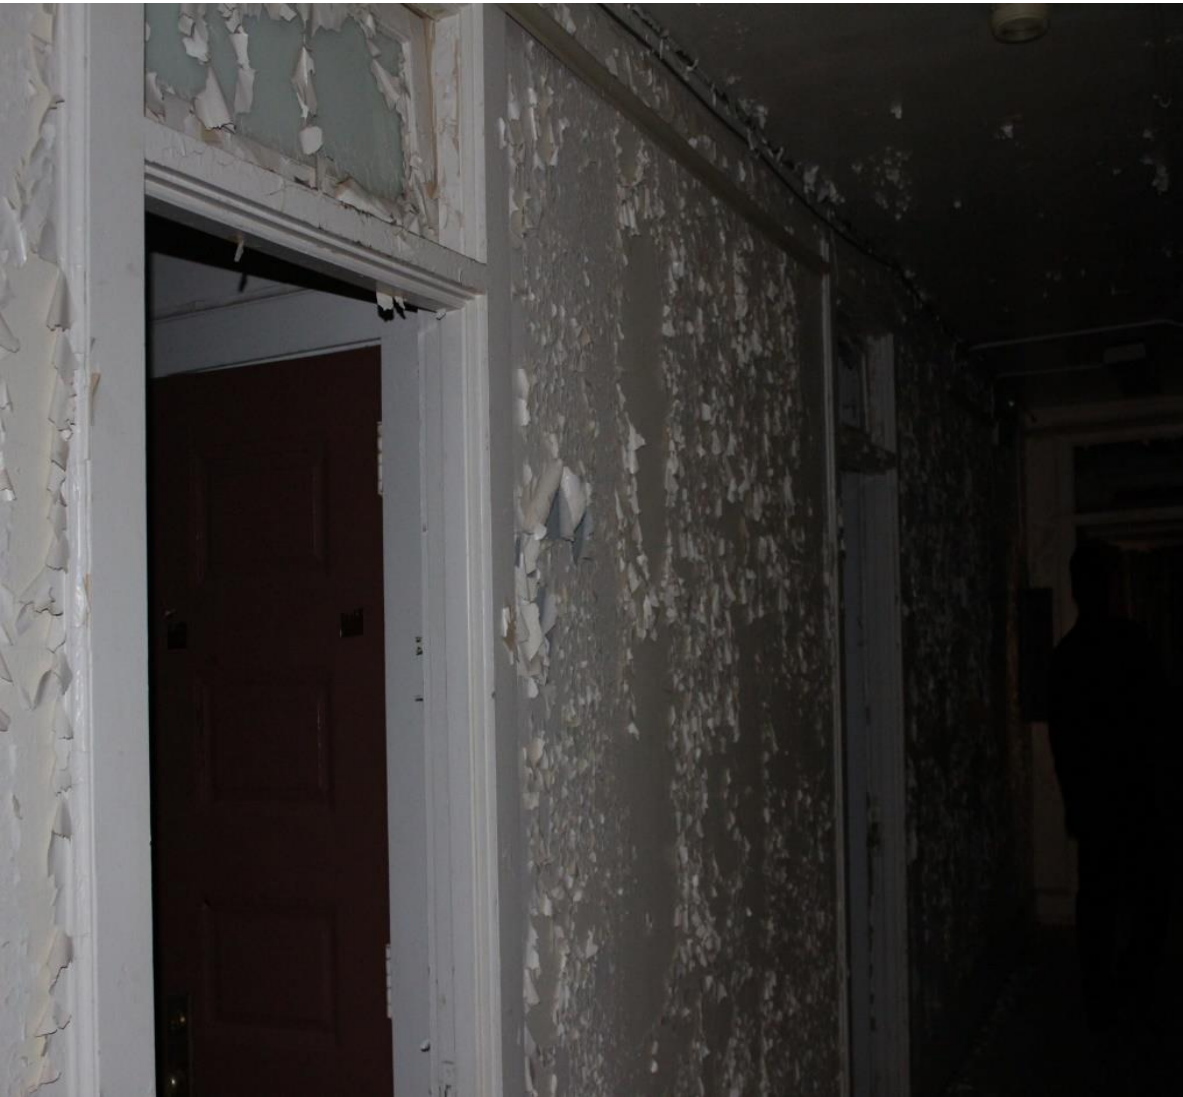
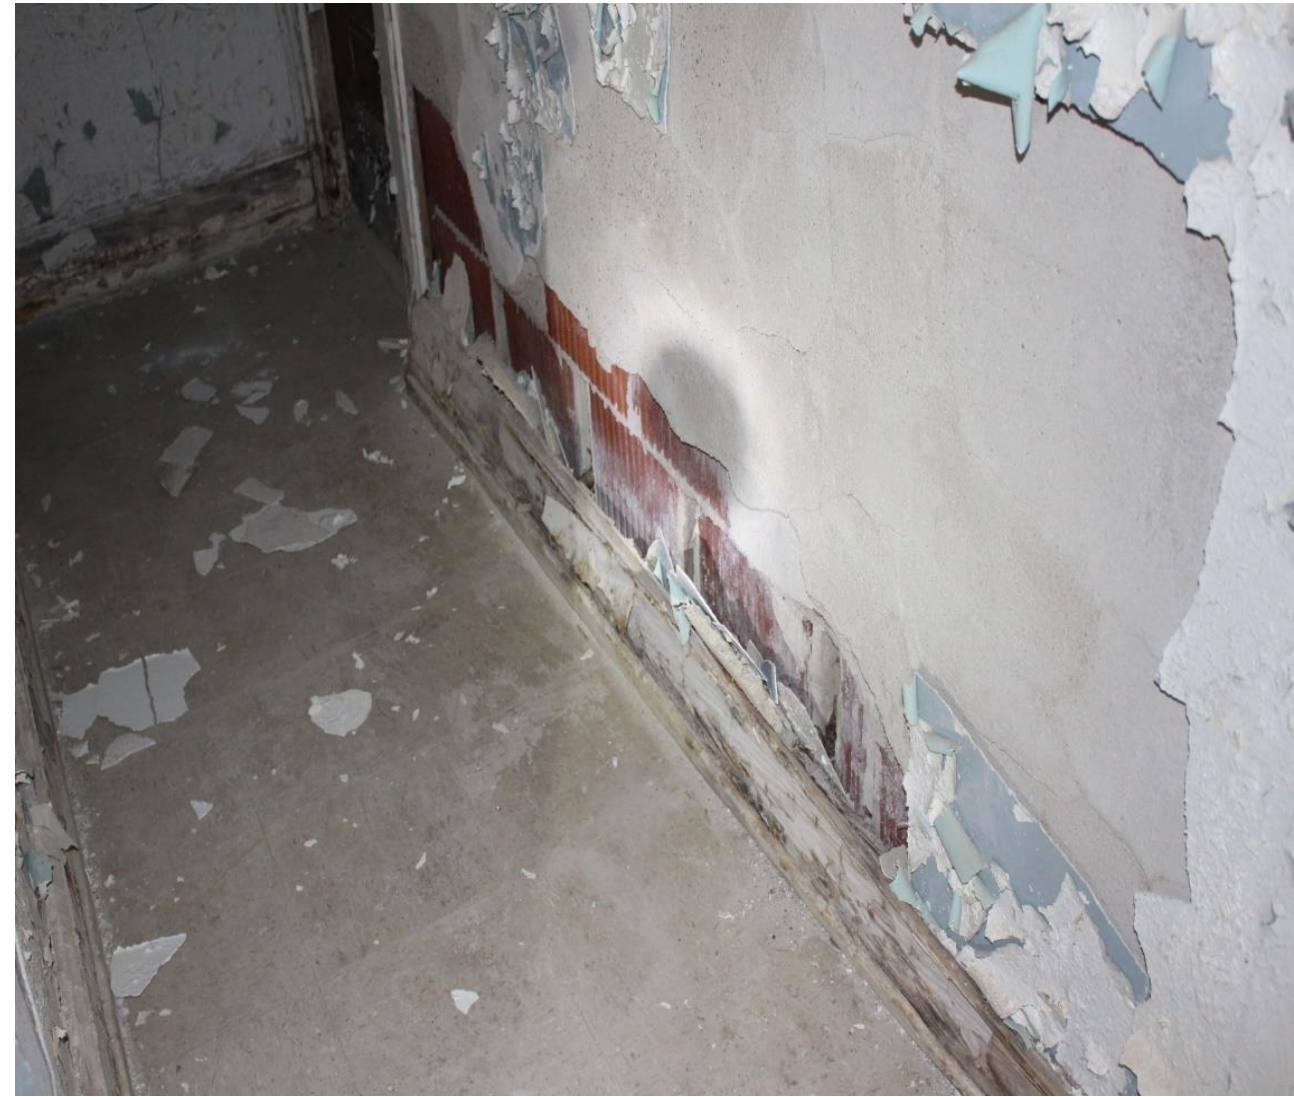
Hurt Hall

The photo on the left shows a typical representation of wood frame doors and possible lead paint. The photo on the right shows the terra-cotta brick with plaster and asbestos floor tile.

- Service 104 students
- Renovation cost \$5,371,000
- ROI of 20 years (ROI Goal is 6 to 8 years)

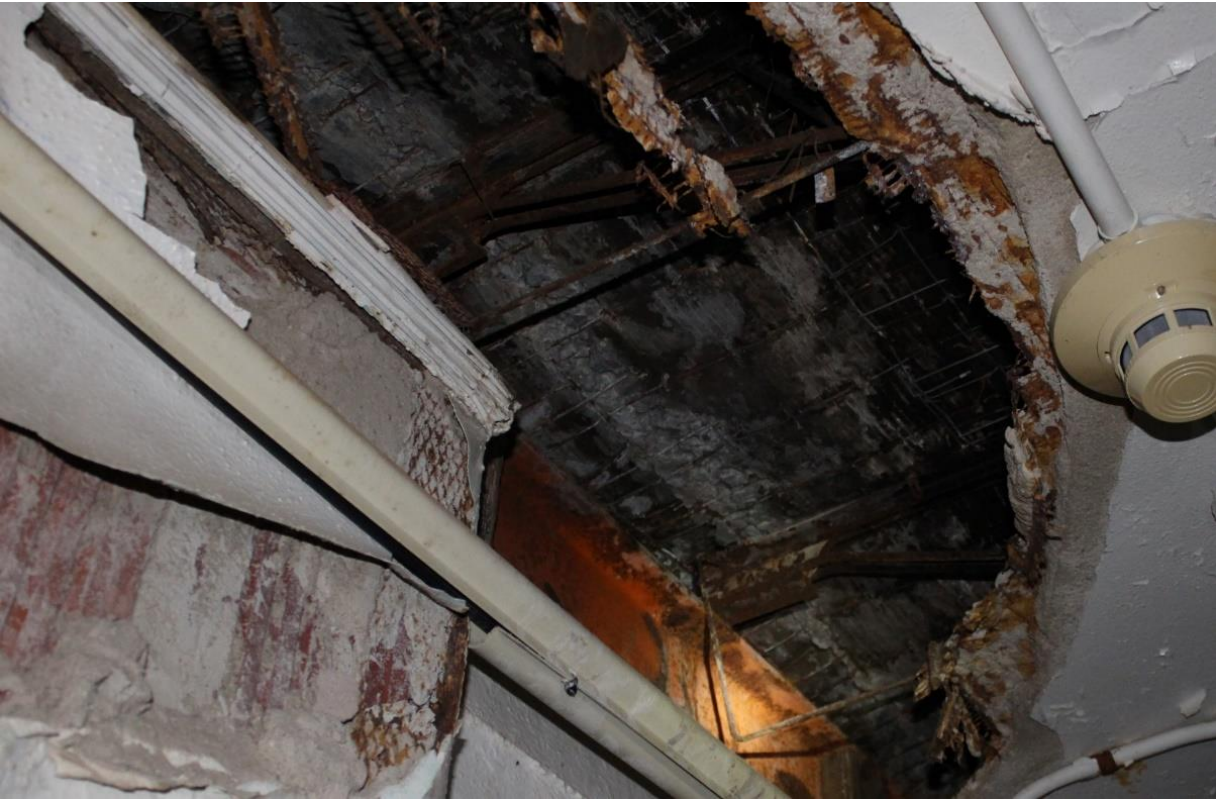
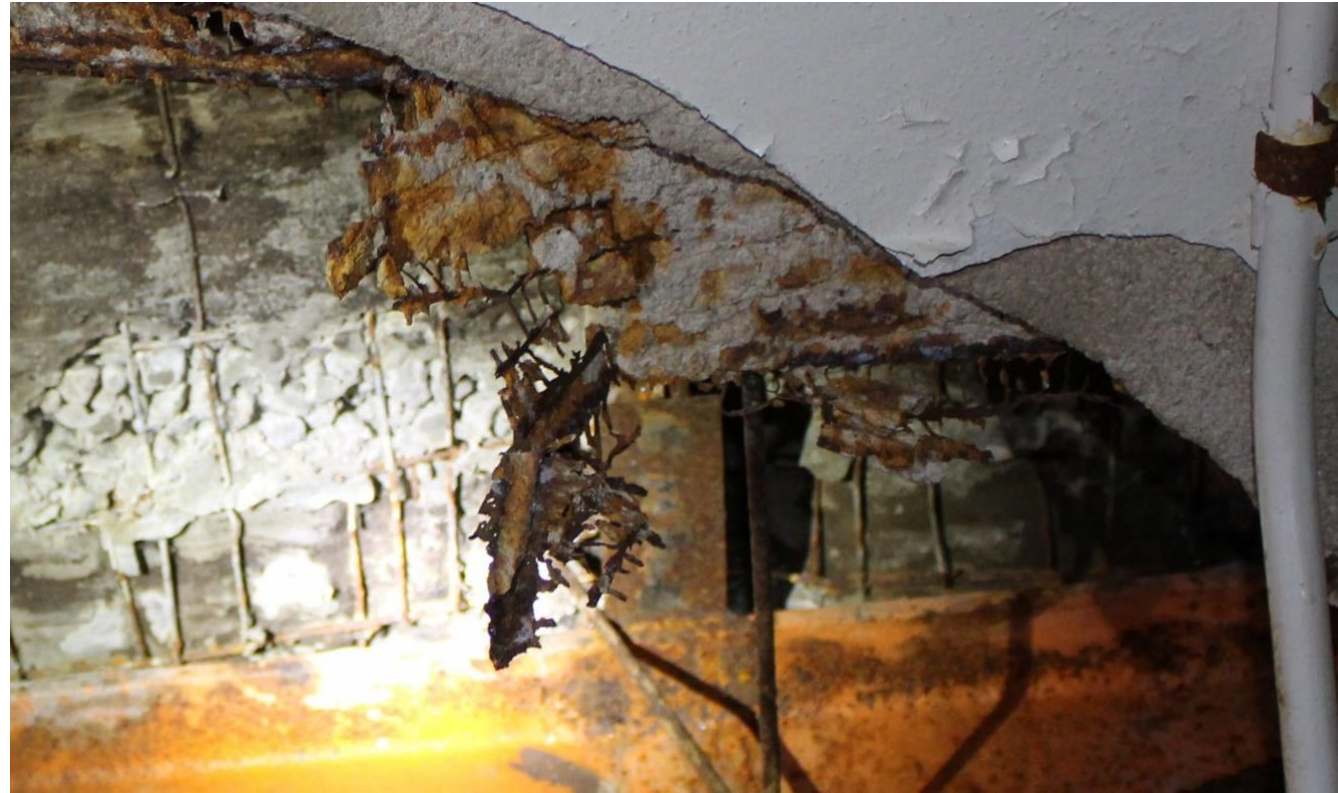
Hurt Hall

The photos below show the deterioration between the mini web joist and the structural load bearing I-beam.
