Alabama A&M University

**Masterplan Revitalization Project
Community Meeting
September 18, 2019**

Masterplan Revitalization Project

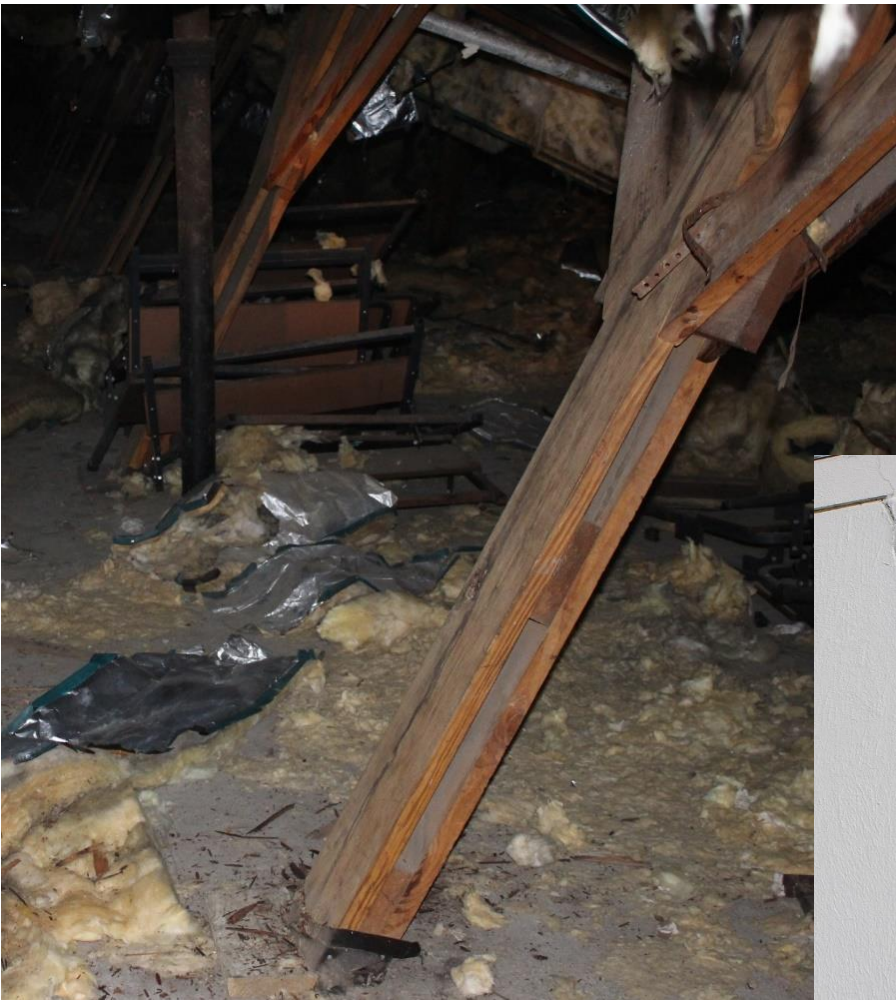
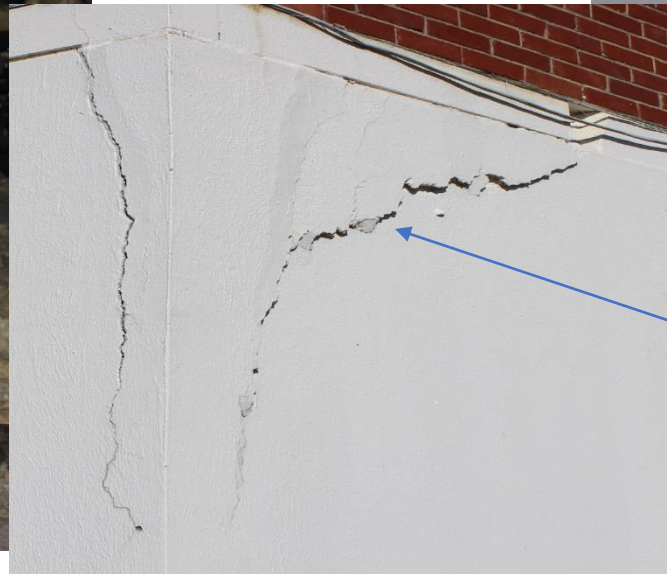
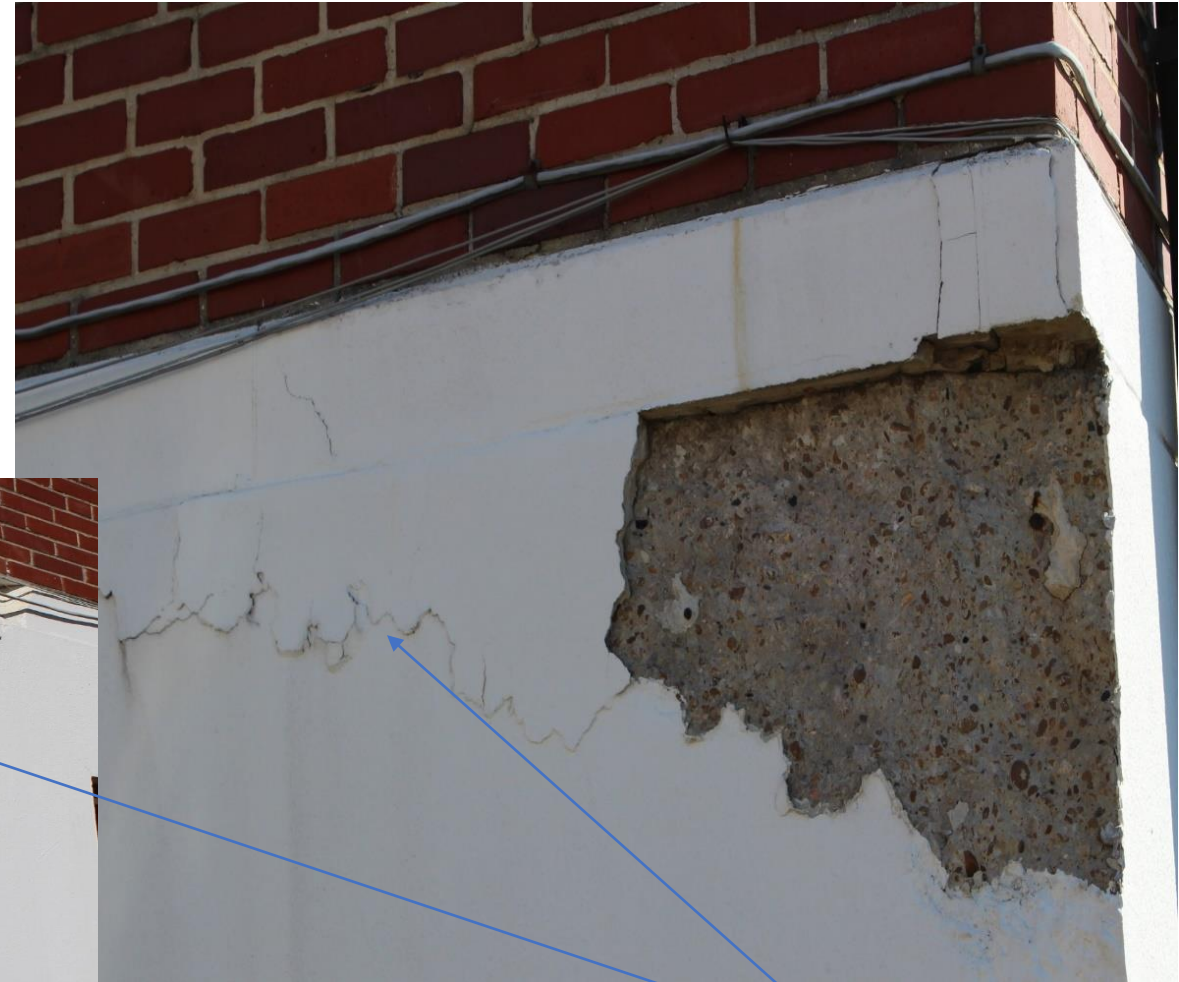
Hurt Hall

The photo on the left shows the roof truss system that rest on the I-beam below as shown in the previous slide. The photos that are centered and on the right show the issues with the likely structural integrity of the building.

Potential
structural issues

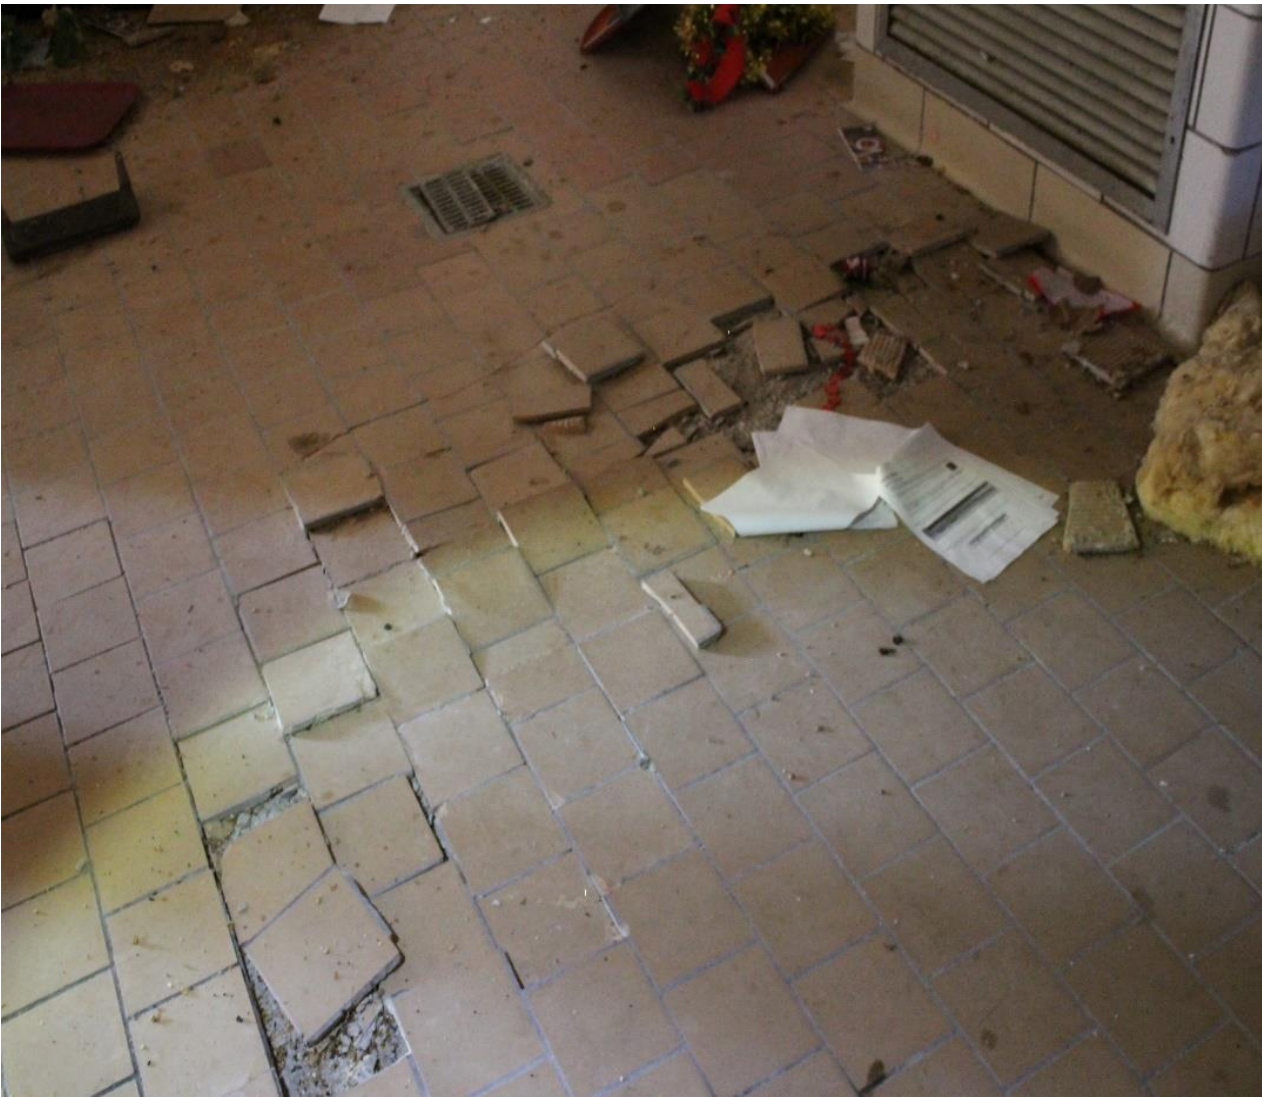
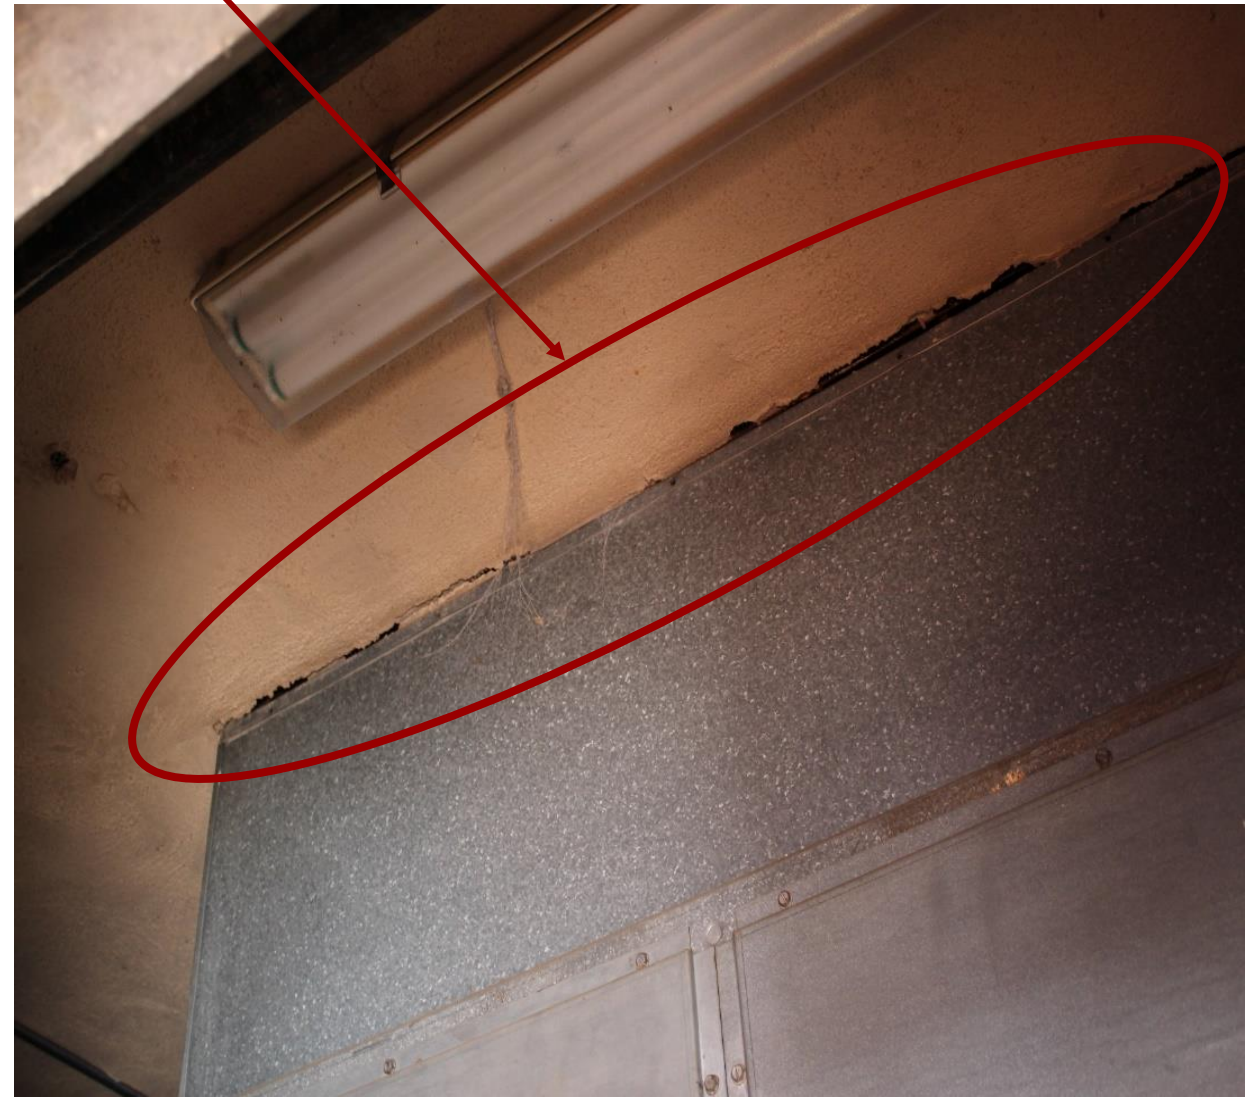
Prentice Dining Hall

The photo on the left shows extensive floor buckling. The photo on the right shows a gap between the duct work and the concrete deck. Both areas are due to the structure shifting and settling.

- Service of approximately 3000 students
- Renovation Cost \$8,750,000
- ROI of 42 years (ROI Goal is 6 to 8 years)

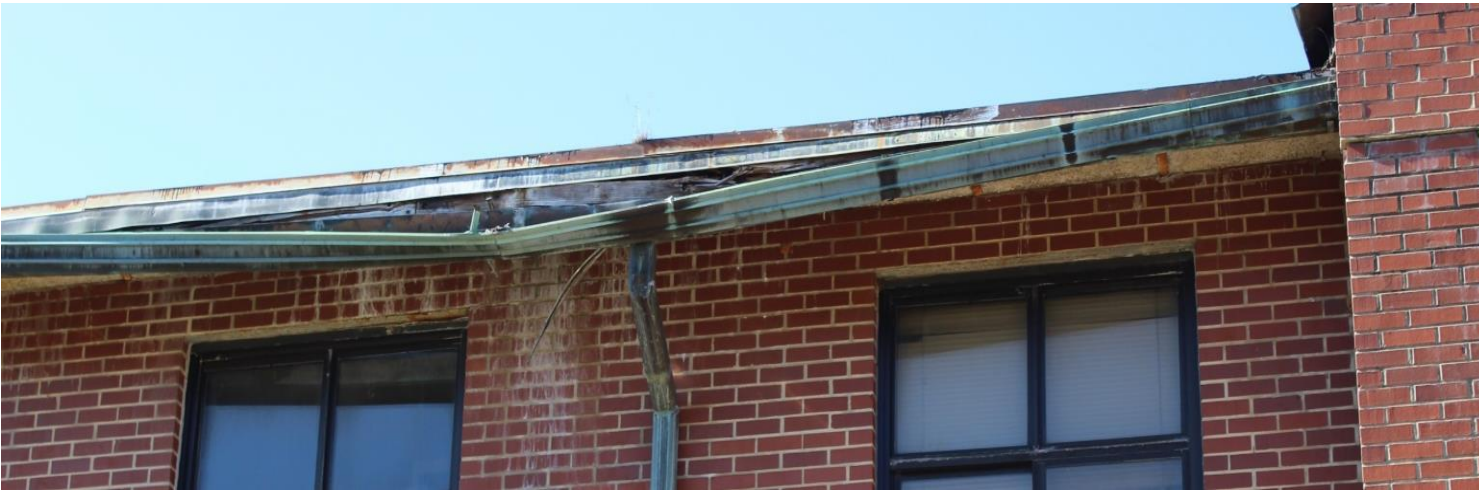
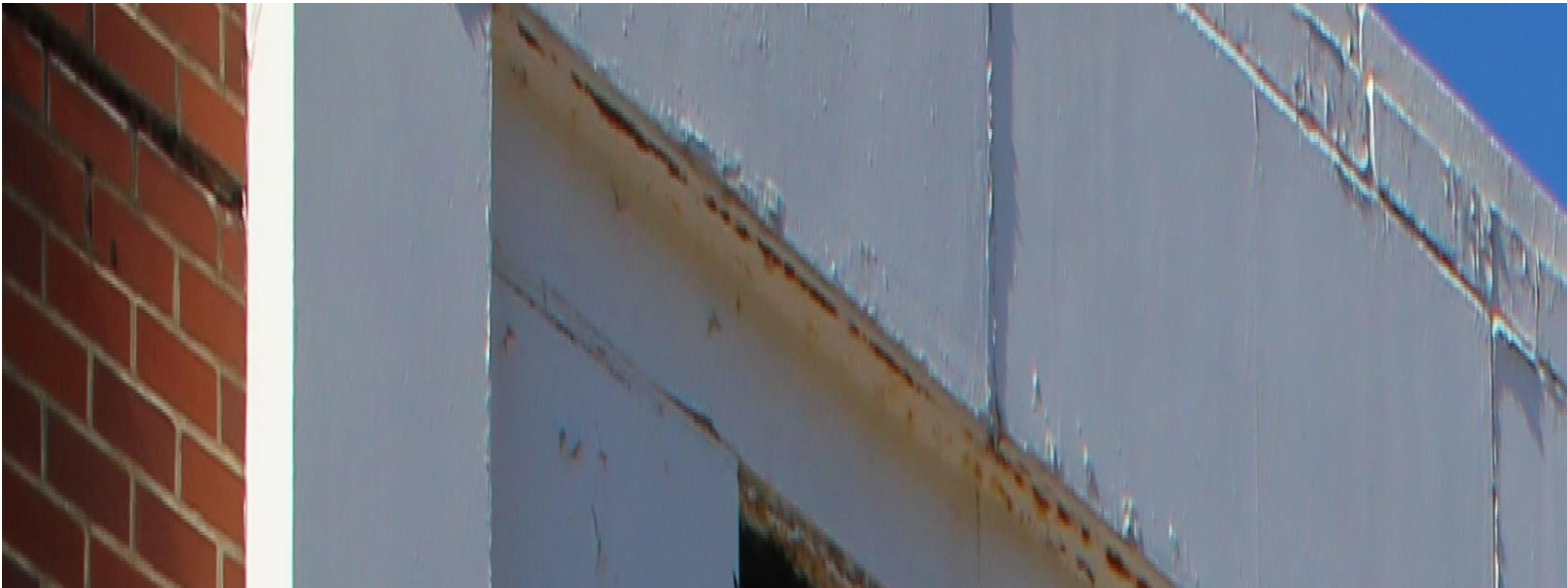
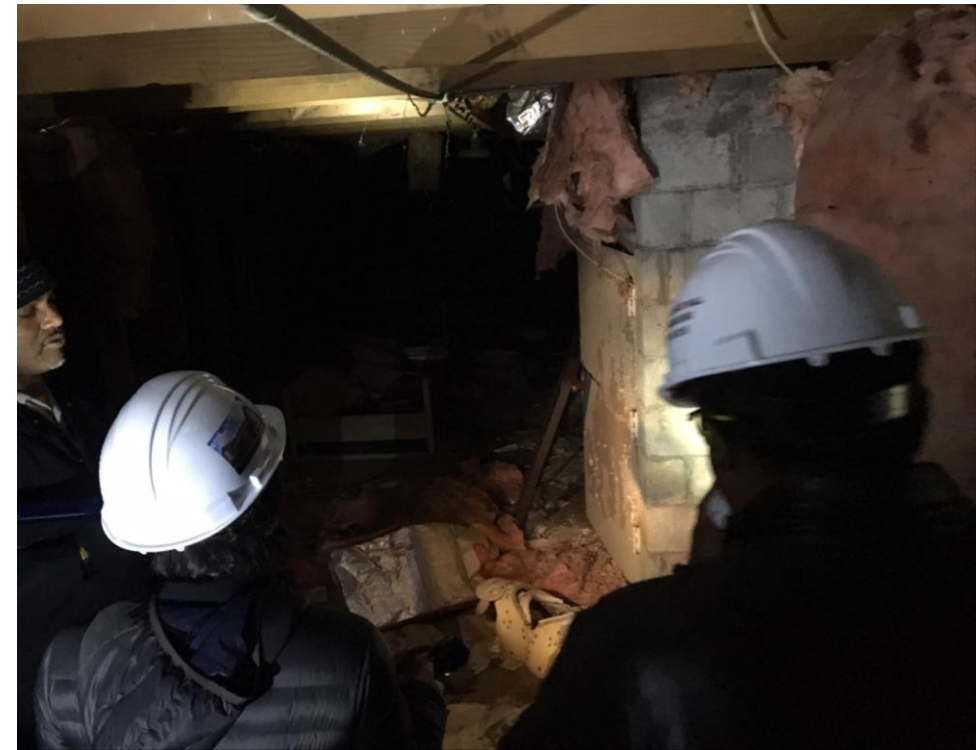
Buchanan Hall

The following photos show various spalling mortar joints and severe soffit, fascia and gutter collapse. These issues along with the roof with deterioration has allowed penetration of rain and storm water runoff into the building which has caused a catastrophic failure of the brick and concrete facade.

- Service 206 students
- Renovation cost \$8,828,000
- ROI of 17 years (ROI Goal is 6 to 8 years)

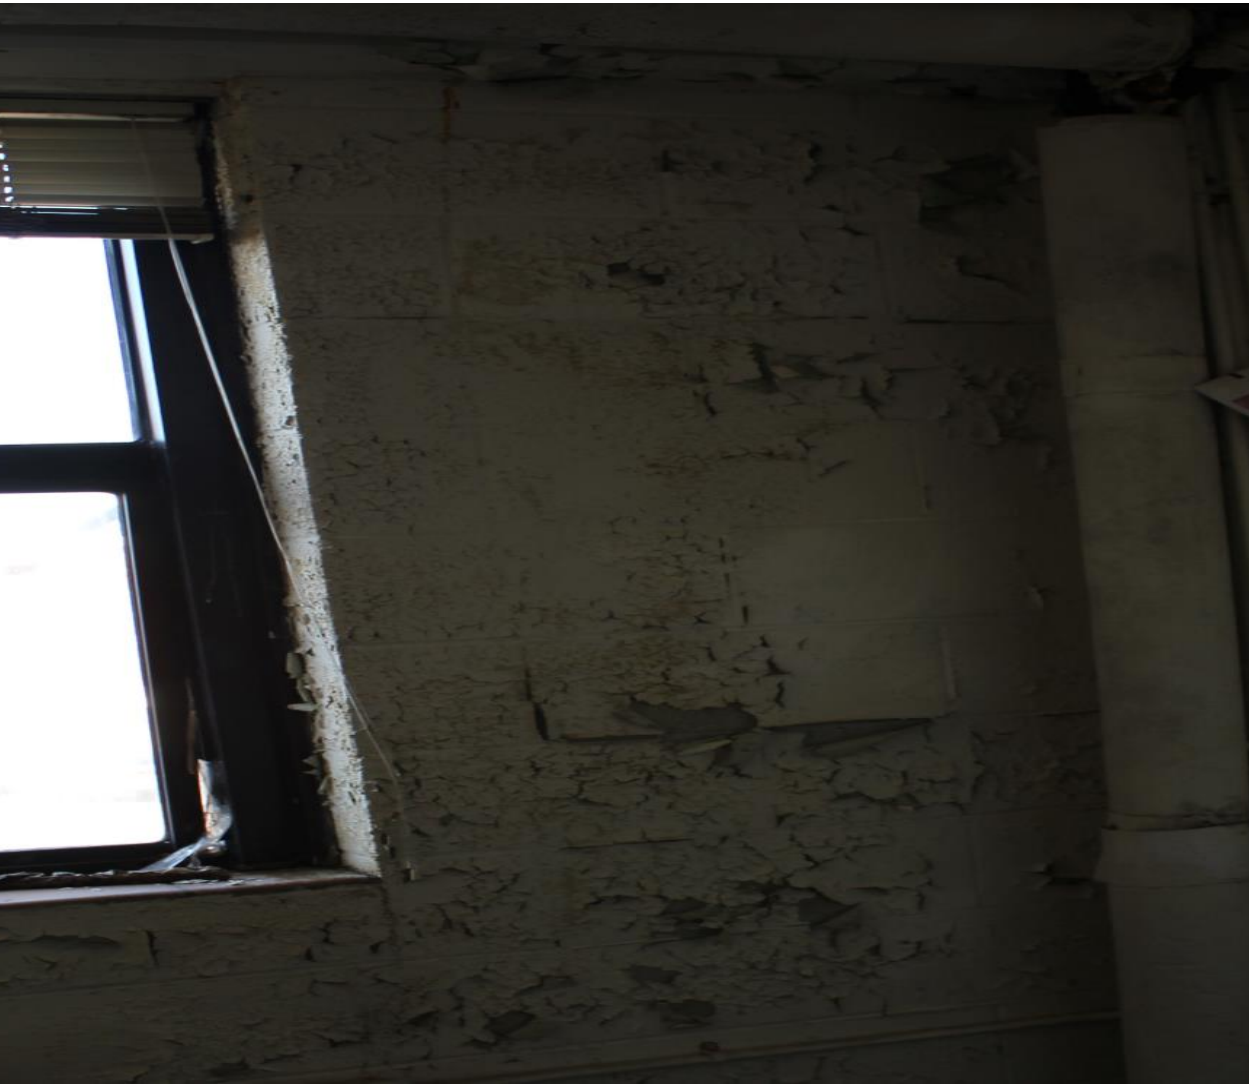
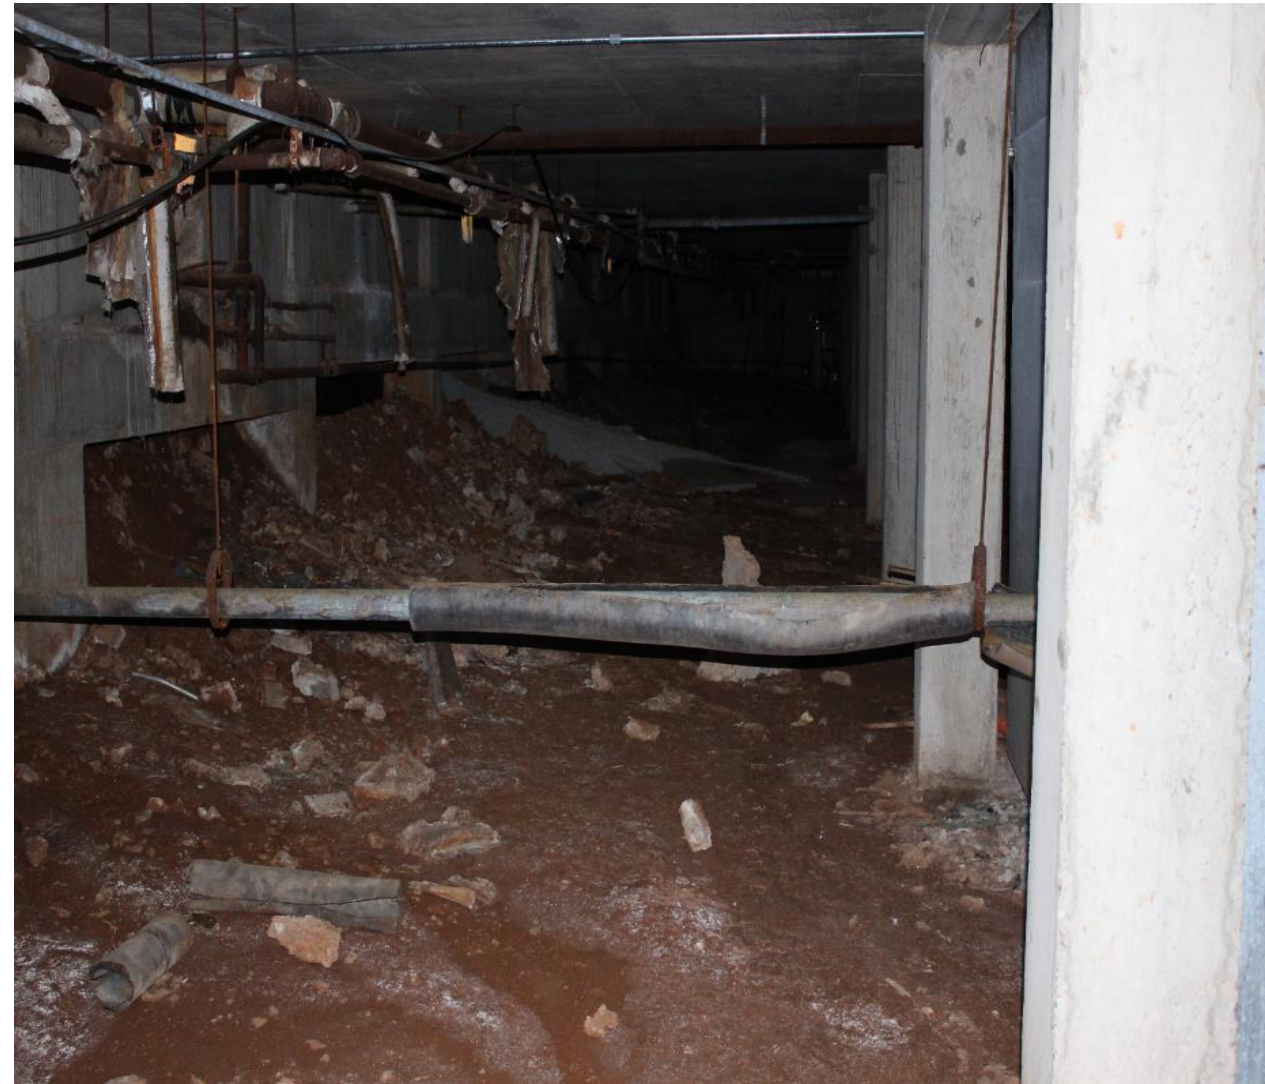
Buchanan Hall

The photo on the left shows extensive paint chipping and mold growth on due to the exterior decline of the building envelope. The photo on the right shows the foundation of the building that is the same as Grayson and Walker Wood, but also show the levelness of the ground. This aspect allows for a future uses at minimal cost.
